Happenings

By Tom Twigge-Molecey

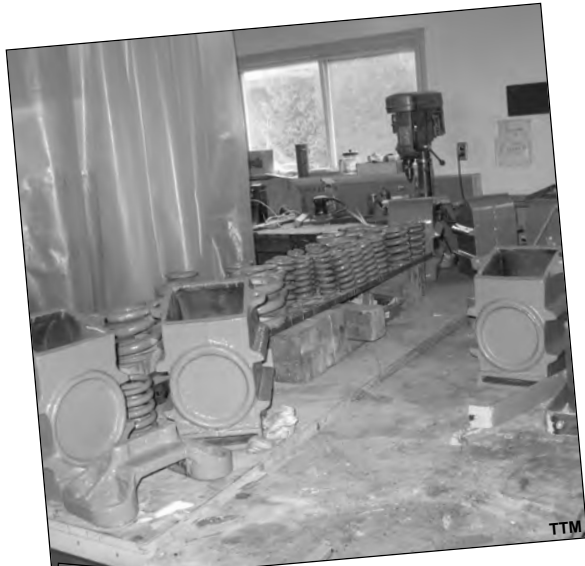
TTC 416

Work on 416 continues at a steady pace. The dismantled trucks have been sandblasted and painted. New pedestal liners are being fabricated to replace the worn out ones from the car. The liners themselves are being manufactured free of charge by a steel company in Guelph. The tapered sockets for the plow bolts are being machined in-house. Once the pedestal liners are installed, the trucks can be reassembled. Work also continues prepping the roof for fiberglass and the reconstruction of the seats is ongoing.

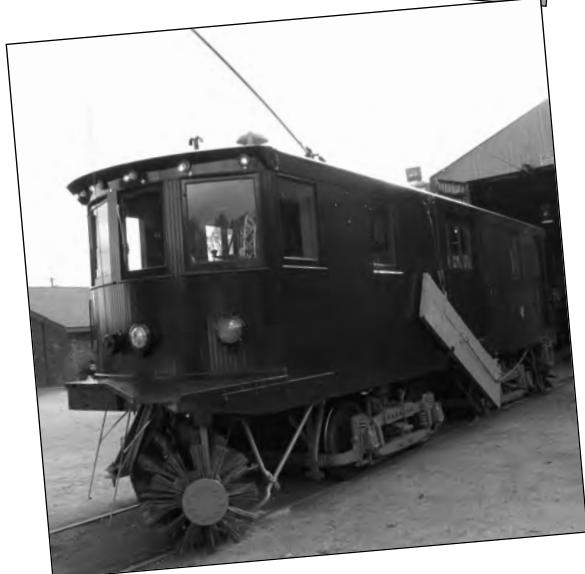
TTC S-37

The clear winner in the progress department is the sweeper. During the past few months, the exterior of the carbody was substantially completed. The trolley boards were removed and the roof repaired. Then the new fiberglass roof was installed and painted. New drip trim along both sides of the car was fabricated and installed. New trolley boards and saddleblocks were installed and painted and the trolley poles and bases were reinstalled. The new siding installation was completed, along with the trim around the east end of the car. A new broom skirt was fabricated and installed on the east end. The hood lights were rewired and reinstalled and the "Eyebrow" above the hood lights was also reinstalled. The headlight, taillight and trolley catcher were also reinstalled. The entire east half of the car was sanded, primed, sanded, painted, sanded and painted again - it just gleams! Work has also continued on the interior, with airbrake servicing and paint stripping and sanding. The north sliding door was repaired and the south sliding door was stripped, sanded and painted. A few weeks of detail work remain and the exterior restoration of the sweeper will be complete after 13 years of work. Congratulations to Ian Smith for an outstanding achievement in seeing this phase of the project right through from start to finish.

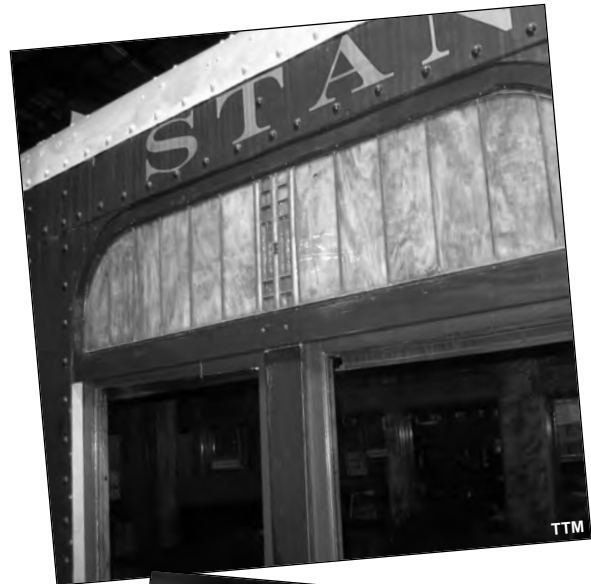
L&PS 8

Half of the car's new mahogany upper sash has now been fabricated and the first two windows installed. The results so far are impressive. Unfortunately, the installation work entails major repairs to the window posts and tracks for the lower sash, so progress on installation has been slow. It is hoped to have half of the car completed by the end of the year. Concurrent with the sash work, the air system has seen constant attention over the past few months. Repeat problems with feed valves caused our master mechanic varying degrees of headache until it was discovered that the relay valve on the triple valve had a slow leak, which led to the brakes not wanting to release. The relay valve was removed, rebuilt and reinstalled and the car has been running problem free ever since.

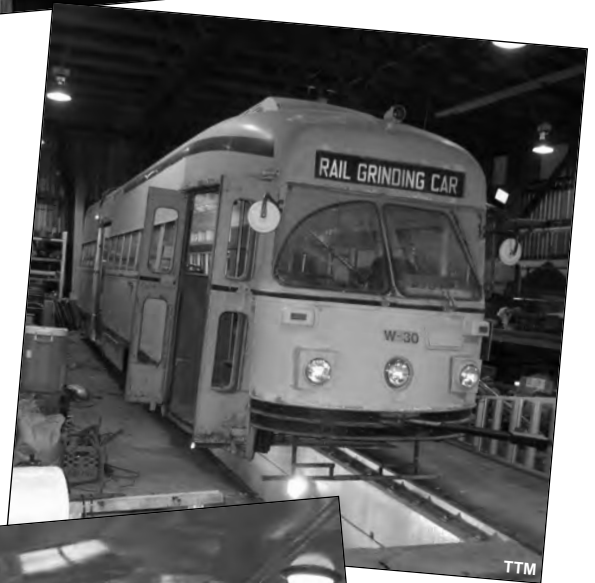
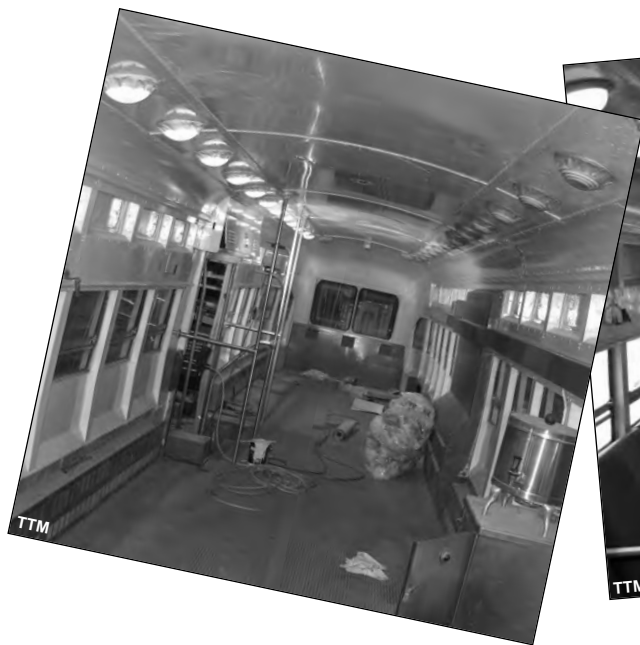
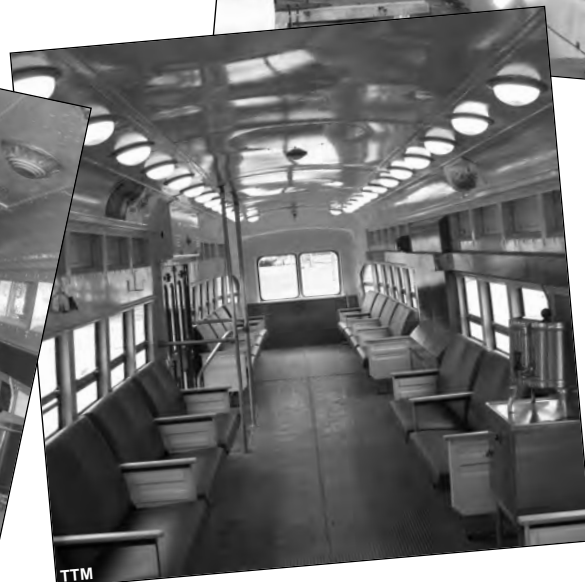
TTC 4600

With all the work on 4611 and W-30 this summer, 4600's bodywork went on the back burner. Recognizing the need for the car for Halloween, the decision was made to put it back in service on a limited basis. To that end, the interior was reassembled. The car card frames and window trim were reinstalled on the closed side, as well as all the seat cushions (all were removed to facilitate the roof repairs). The interior was half repainted. Thanks to Jim Sorensen, John Johnson and Caroline Rose for putting the interior back together. The car was serviced and inspected and is back in limited service.
